Project name: Birchgletscher Fact sheet
Document code: 88028-VAW-2025-06
Authors: Daniel Farinotti, Matthias Huss, Mylène Jacquemart, Mauro Werder
(with input from Olivier Glagliardini, University of Grenoble-Alpes, France, and Thomas Schuler, University of Oslo, Norway)

Fact sheet for the now-collapsed Birchgletscher, Switzerland

SUMMARY: On Wed 28.05.2025, ~15:30 CEST, the glacier known as Birchgletscher (Valais, Switzerland), collapsed under the weight of the rock-debris that had accumulated on its surface due to a series of rock avalanches originating from Kleines Nesthorn, a mountain peak that became unstable in the course of the preceding week. This factsheet provides our present understanding of the situation, including key background information for the glacier, its pre-event behavior, the role of permafrost, possible links to climate, and information about comparable events involving glaciers in the past.

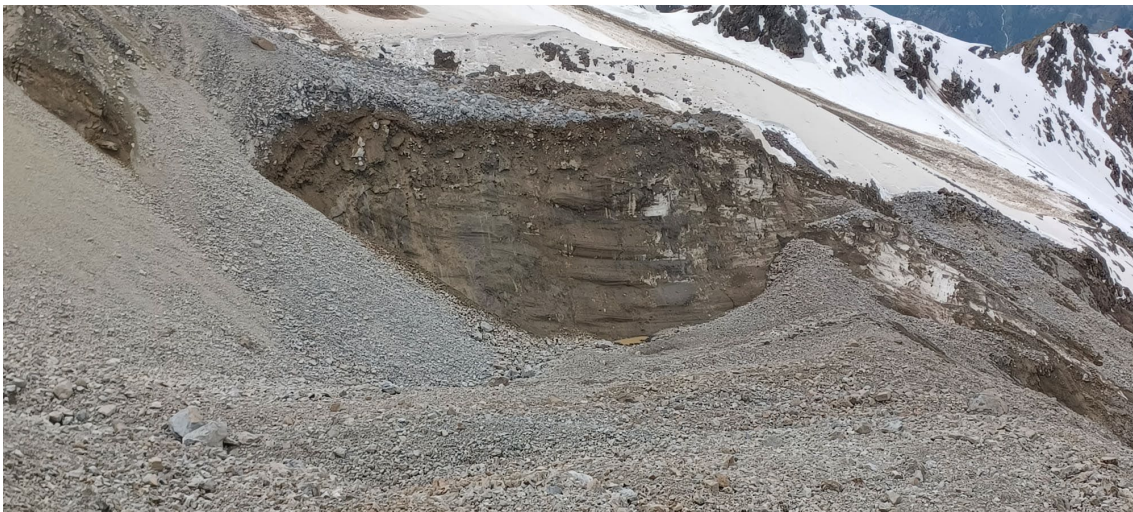
Bedrock of Birchgletscher after the glacier detachment. Photo: 01 June 2025, D. Farinotti

The situation of the glacier before and after the collapse is illustrated by [Rapid mapping](#) acquired by the Federal Office of Topography swisstopo (<https://s.geo.admin.ch/y1o40mtw055l>). This indicates that the entire lower section of Birchgletscher has disappeared (0.14 km²).

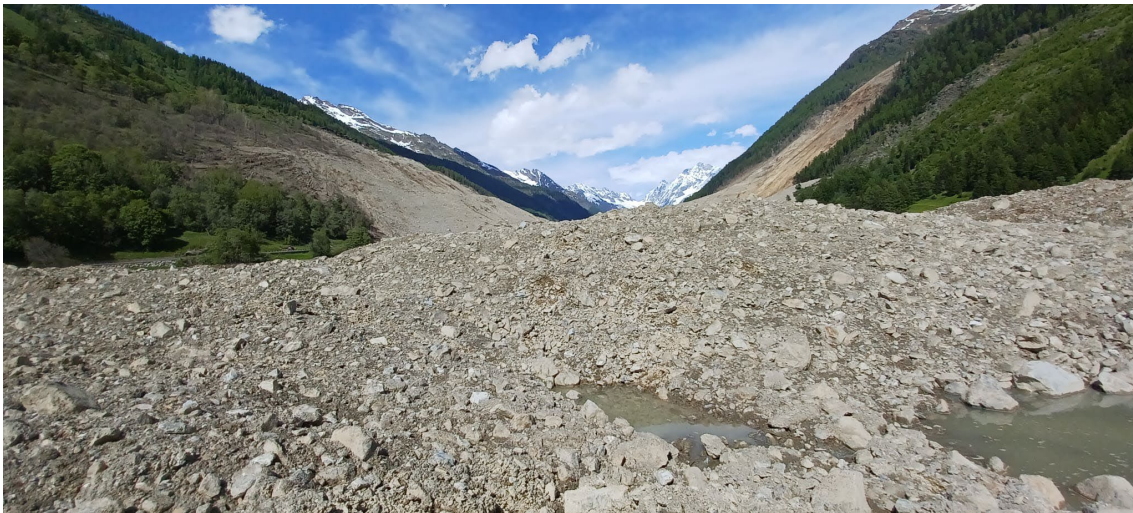
Deposition in the valley floor. Photo: 01 June 2025, D. Farinotti

Combined, these factors likely resulted in a rapid rise of englacial water pressure and, thus, reduced basal friction, as indicated by the acceleration of the ice flow before the failure. This eventually destabilized the entire lower and thicker part of the glacier (estimated at 3 million m³ of ice), and caused a catastrophic rock-ice avalanche burying the village of Blatten. With an estimated rock debris that accumulated on the glacier surface in the order of 3 million m³ (or ca. 9 million tons) and the mobilized glacier volume, the rock-ice avalanche released a large amount of potential energy over the elevation difference of 1,000 meters. This energy would be sufficient to melt several 100,000 tons of ice, and might have resulted in the melting of around 10% of the involved ice volume. The resulting rock-debris and ice mixture led to the damming of the river Lonza, which flows in the valley below the glacier.
